Some characteristics of grounded floebergs near Prudhoe Bay, Alaska

Austin Kovacs and Anthony J. Gow

September 1976

COLD REGIONS RESEARCH AND ENGINEERING LABORATORY

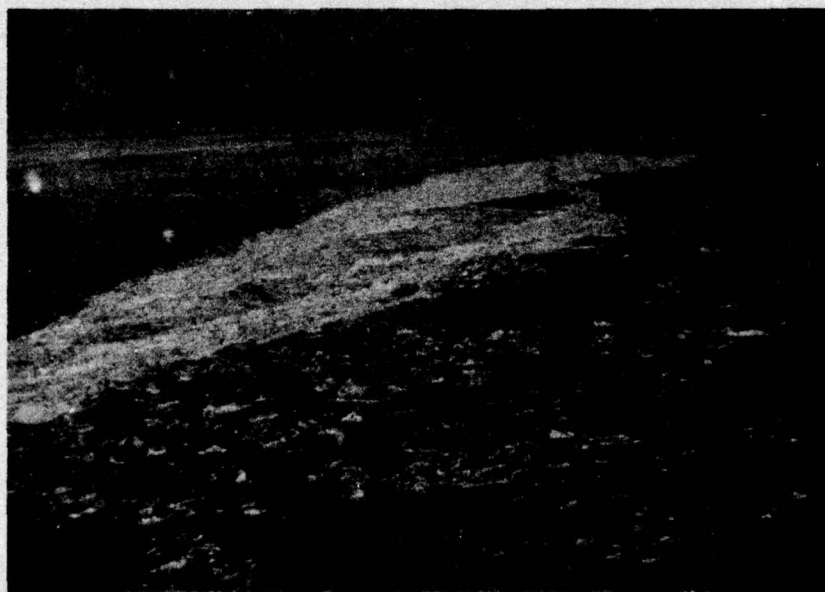
Figure 2. Aerial photographs of ice features in the immediate area of the study site.

a. Deformed zone marking boundary between fast ice and the moving pack.

The area of the study was located approximately 12 km north of Long Island (Fig. 1). Two aerial views of the area are shown in Figure 2. The highly deformed zone of sea ice shown in Figure 2a occurs at the boundary between the fast ice and the moving pack. This formation is composed of shear ridges which are the result of the shearing forces developed at the boundary. This particular formation, often much longer and wider, is known to re-form each year at this location. The first report of the occurrence of the shear ridge fields in these waters was, perhaps, that of Stockton (1890) who observed one formation 16 km long that was grounded in 24 m of water.

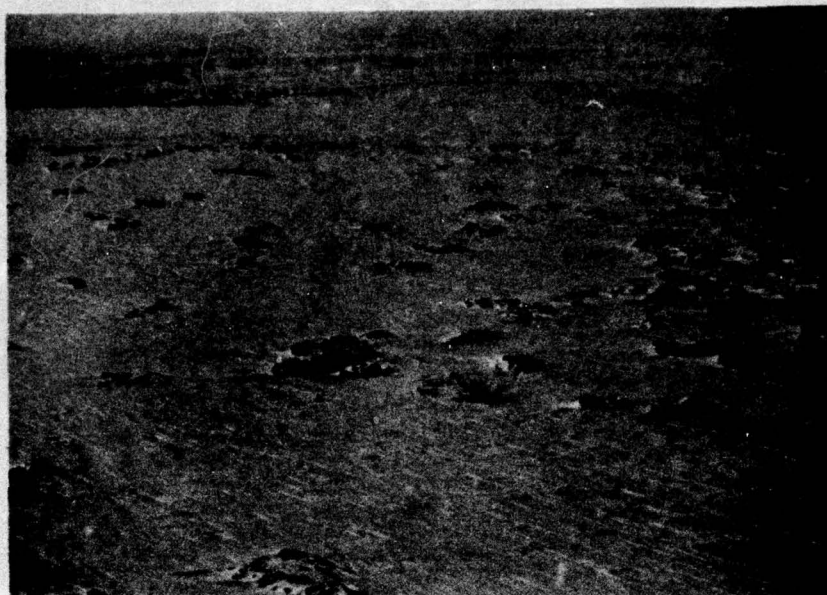
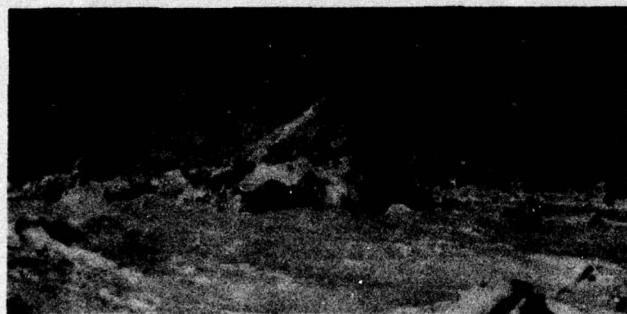
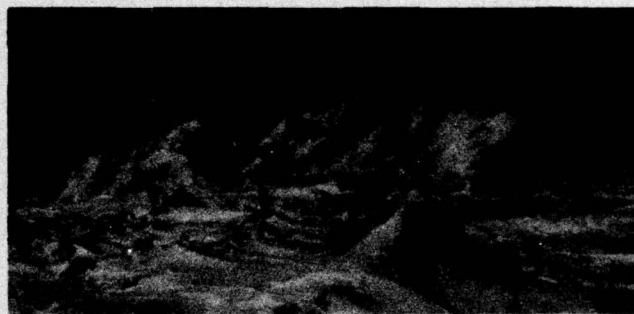
Figure 2 (cont'd).

b. Grounded floebergs.

Enlarged views of floebergs.

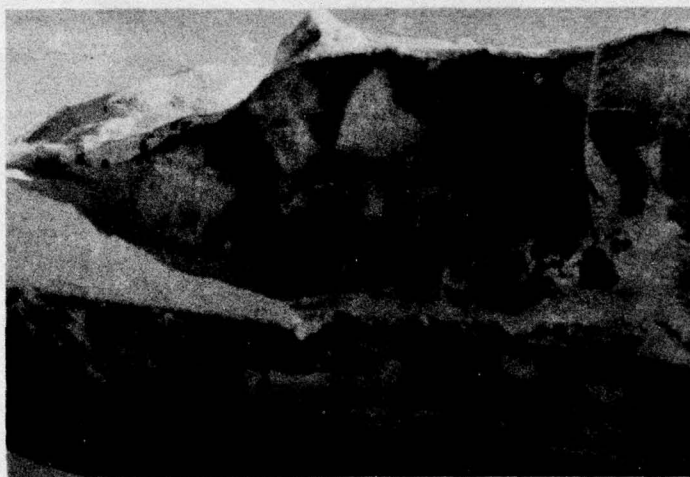
Figure 12. Exposed portions of two floebergs showing structural arrangement of ice blocks. Ice at each location contains abundant algae remains and some sedimentary material (dark patches). Note also the distinctive layer of debris (arrows) on exposed, ablated surfaces of floebergs.

were composed of tabular blocks and assorted fragments of ice, ranging in size from a few centimeters to several meters across, and firmly cemented together with little or no trace of voids. Internal structure was best revealed in the exposed faces of floe-bergs that had split apart, and some typical examples of such structure are presented in Figure 12 and the photograph on the cover.

All floebergs contained variable quantities of debris enclosed within and between the blocks of ice. Most of this debris was organic, composed principally of brown algae that had obviously been trapped in the ice during freezing. Sedimentary material was identified as of mainly silt-clay composition, though sand and gravel-sized debris (Fig. 13) were occasionally observed. The finer sedimentary particles are probably of eolian origin, but the exact source and manner of entrapment of the coarser particles, e.g. pebbly sand, has not been firmly established.

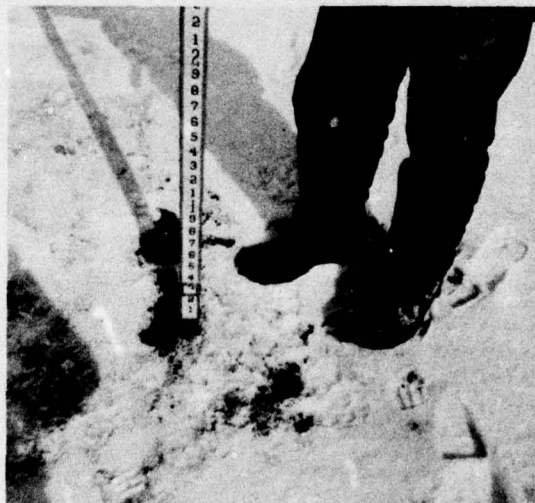
Figure 13. Deposit of coarse sand and a fragment of tundra mat observed at foot of floeberg A.
